1010-CC130-172304 (DFS 2-7)

Flight Safety Investigation Report

**CANADIAN ARMED FORCES
FLIGHT SAFETY INVESTIGATION REPORT (FSIR)**

Final Report

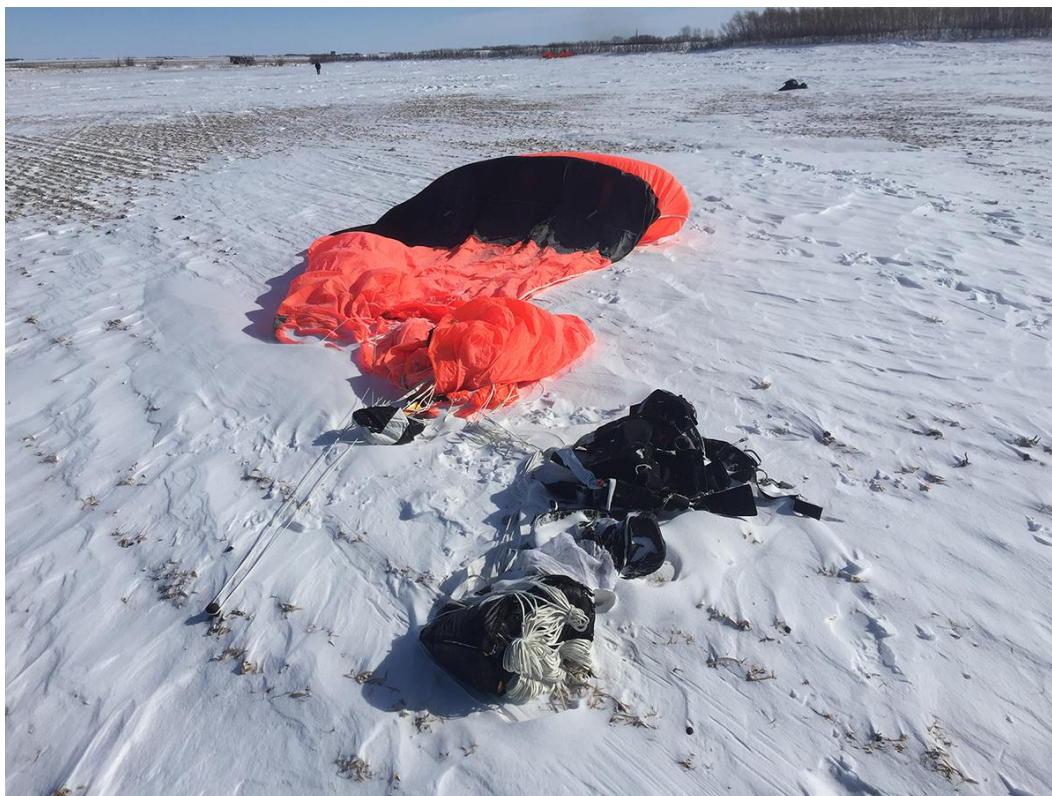
Figure 2: TM Canopy and Harness in situ, looking southeast.

1.3.1. The parachute was examined in detail by the Canadian Armed Forces (CAF) Senior Parachute Rigger, his staff, and specialists from the Escape Systems section of the Aerospace Engineering Test Establishment. The right rear riser had a significant cut, caused when the TL used the hook knife to cut the RSL in an attempt to release the TM from his parachute to perform first aid.

There was a dark brown mark noted on one of the left side suspension lines but the suspension line itself was in good condition. The reserve pack metal stiffener was slightly bent and the reserve closing loop was found snapped apart. There was no other apparent damage to the harness, the suspension lines, the canopy, or the associated hardware. Specifically, there was no evidence (marks, material transfer or other damage) to indicate that a line had become trapped over top of the canopy (known as a “line over”).

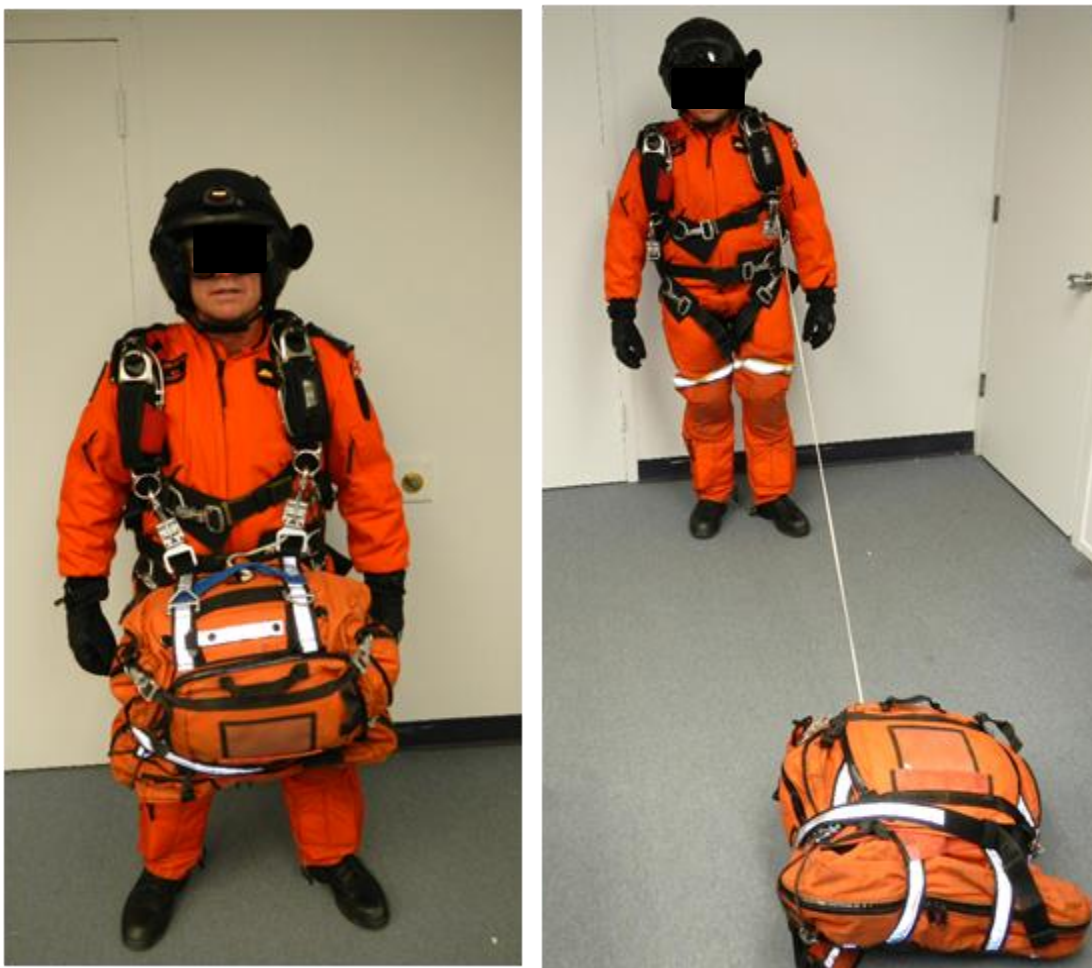
Figure 5: SAR-PELS attached and released

1.15.4. The TM's SAR-PELS was well used and minor wear/damage was evident; however, it could not be determined if the damage was pre-existing or occurred on the accident jump. The leg strap lengths were consistent with the amount of adjustment required to fit the TM and there was no physical evidence

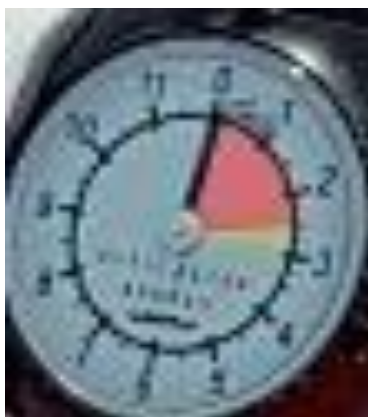
1.15.3. The TM was wearing an approved wrist altimeter. The analogue display is similar to that of a clock with the 'hour' marks corresponding to each 1,000 ft AGL increment and the altitudes below 2,500 ft shaded pink (see Figure 6). The altimeter was noted to be reading zero feet at ground level in the landing area.

Figure 6: Parachutist Wrist Altimeter

3.1.14. The TM was wearing an approved and properly set wrist altimeter. [1.15.3]
