1010-CC130-172304 (DFS 2-7)

Flight Safety Investigation Report

**CANADIAN ARMED FORCES
FLIGHT SAFETY INVESTIGATION REPORT (FSIR)**

Final Report

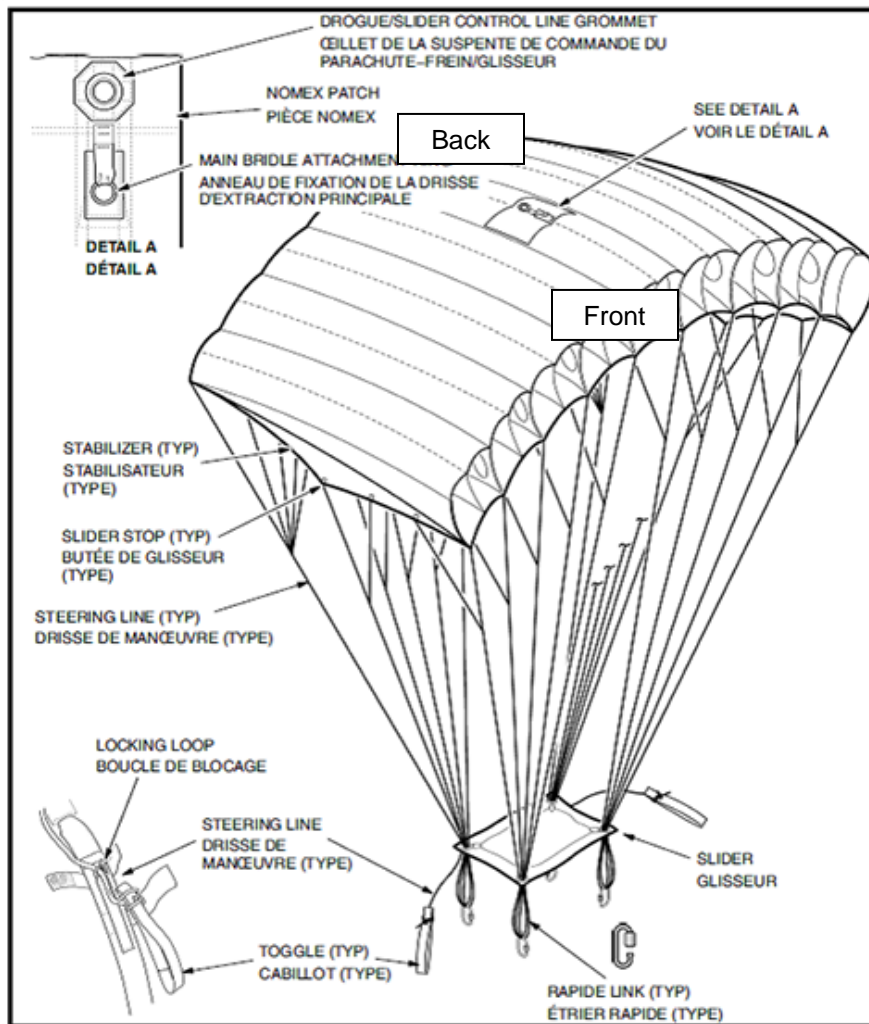
Figure 3: CSAR 7(A) Main Canopy Schematic

1.6.8. The canopy is certified for a maximum suspended load of 375 pounds. The main canopy (see Figure 3) is connected to the risers via four braided polyester suspension line groups, each with five suspension lines. The suspension lines distribute a suspended load under the canopy without distorting the canopy's airfoil shape. Upper control lines converge from points of attachment on the left and right trailing edges of the tail, respectively, to common connection points with the lower control lines. The lines attached to the trailing edge are the steering lines which in turn are connected to a left and right steering toggles.

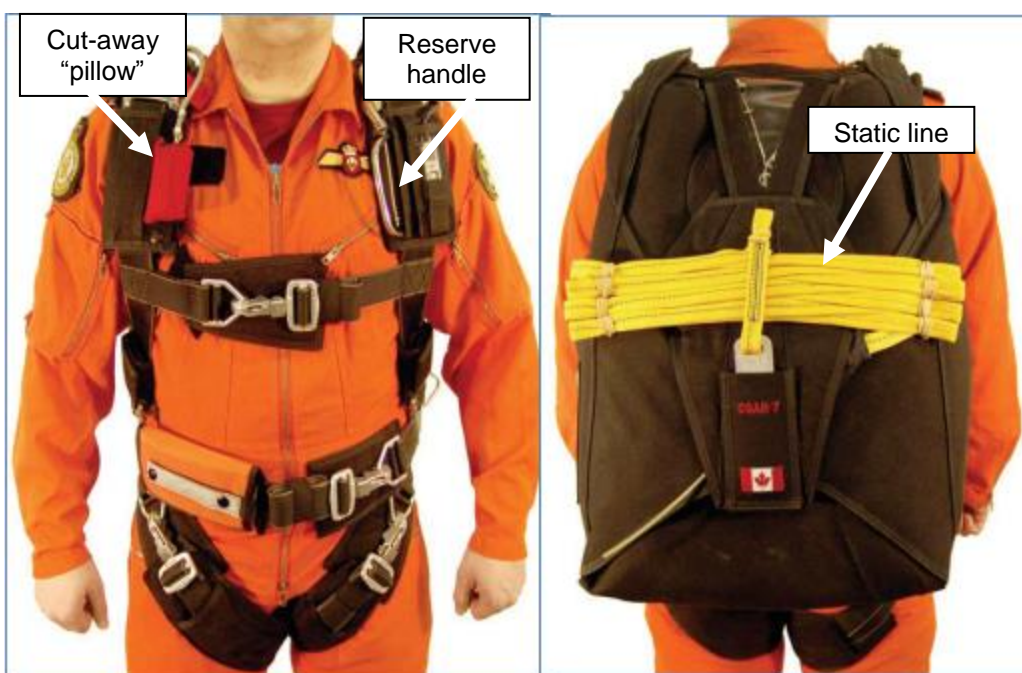
Figure 4: CSAR 7(A) Harness and Pack

1.6.11. The harness (see Figure 4) is made of wide nylon webbing and is an integral part of the pack. The harness incorporates hardware for the three ring canopy release, D rings and webbing loops for equipment and carrying pockets, and housings for the main, reserve and cut-away ripcords.
